News from the City of Greenville

City Fire Department Orders Evacuation Moves to Stabilize Buildings on South Main Street

Structural engineers document rotted ceiling and collapsed beams making Polycraft Building dangerous, jeopardizing safety of adjoining buildings

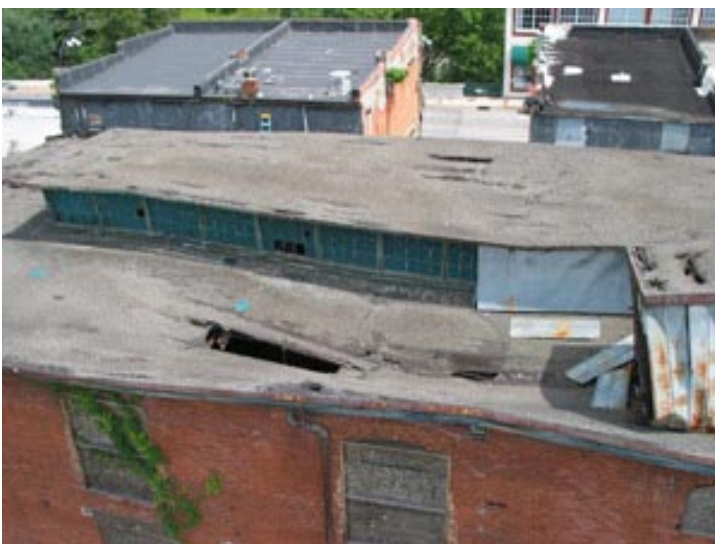
An aerial view of the Polycraft Building showing a collapsing roof. At top, the South Main buildings that share the unstable wall.

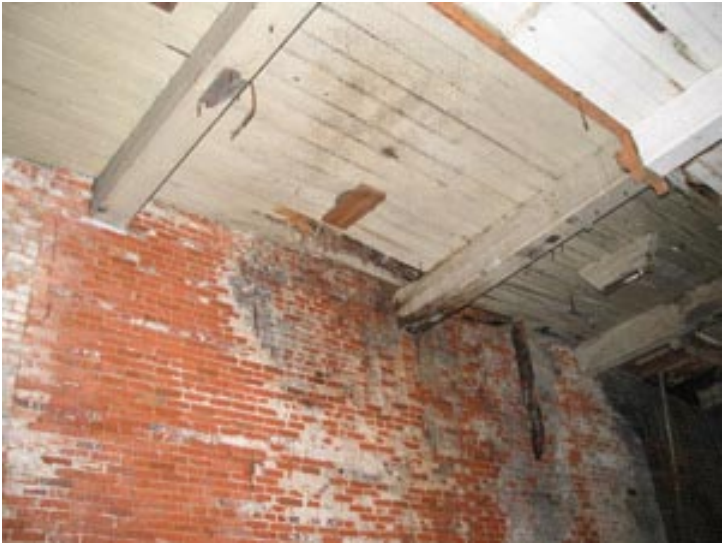
Structural engineers and Fire Marshall say water damage and falling retaining beams that once supported the wall will cause the shared wall to collapse taking neighboring structures with it. The exact time or direction of the collapse is unpredictable.

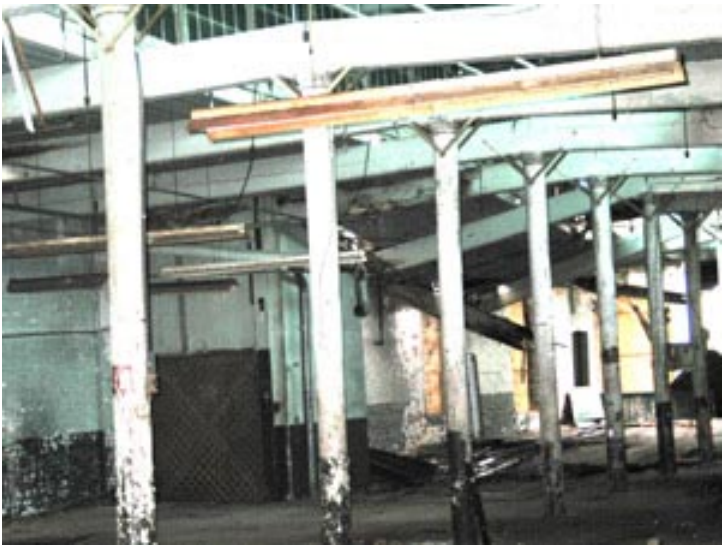
Fallen and split beams undermine support of the shared wall. Light streams into the building through large gaps in the roof.
